TESTS OF EFFECTS OF LONG DURATION BLAST-TYPE FLOWS ON FIRES IN
INTERIORS (INCLUDING EOC'S)

INTERIM TESTS OF THE EFFECTS OF LONG DURATION BLAST-TYPE FLOWS ON FIRES IN URBAN INTERIORS AND ON THE CONTENTS OF EMERGENCY OPERATING CENTERS (EOC)

C. Wilton
R. Kaplan
SCIENTIFIC SERVICE, INC.
1536 Maple Street
Redwood City, California 94063

Contract No. DAHC20-73-C-0195
DCPA Work Unit 2563A
COTR - Dr. Michael A. Pachuta

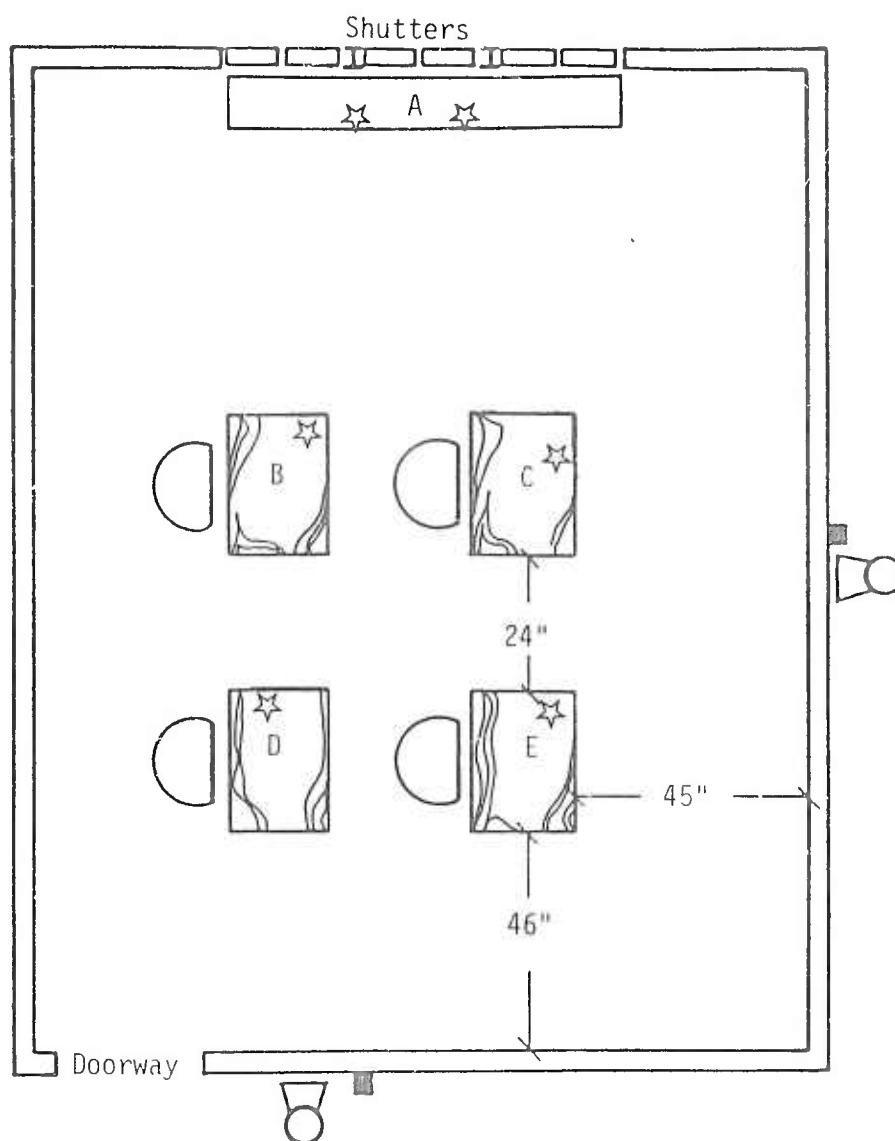
Fig. 5-1. Sketch of Test Geometry, Test Number 5

Four school desks were placed as shown in the sketch in Fig. 5-1. Papers were placed in the desks, on top of the desks and on a shelf directly in front of the shutters. Six ignition sources were used, one on each desk and two on the shelf. See pretest photographs Fig. 5-2.

A - 12 x 60 in. shelf

B, C, D, & E - 23 x 18 in. school desks

☆ Ignition sources

All sources ignited. Once the shutters opened it appeared that the flames were quickly extinguished. Desk D (See Fig. 5-1) tipped over and ended up against the back wall. Desks B, C, and E moved slightly but remained upright. Papers were spread throughout the room and in the corridor outside the doorway. Posttest photographs of the room are presented in Figs. 5-3 through 5-4.

This test was essentially a duplicate of Test 5, with a similar arrangement of desks and combustible materials (See Figs. 5-1 and 12-2). Results of the two tests were quite similar; all combustible materials were extinguished and papers were scattered about the room and into the hallway. None of the desks tipped over (one did in test 5) and they were displaced only slightly (See Fig. 12-3 and 12-4).

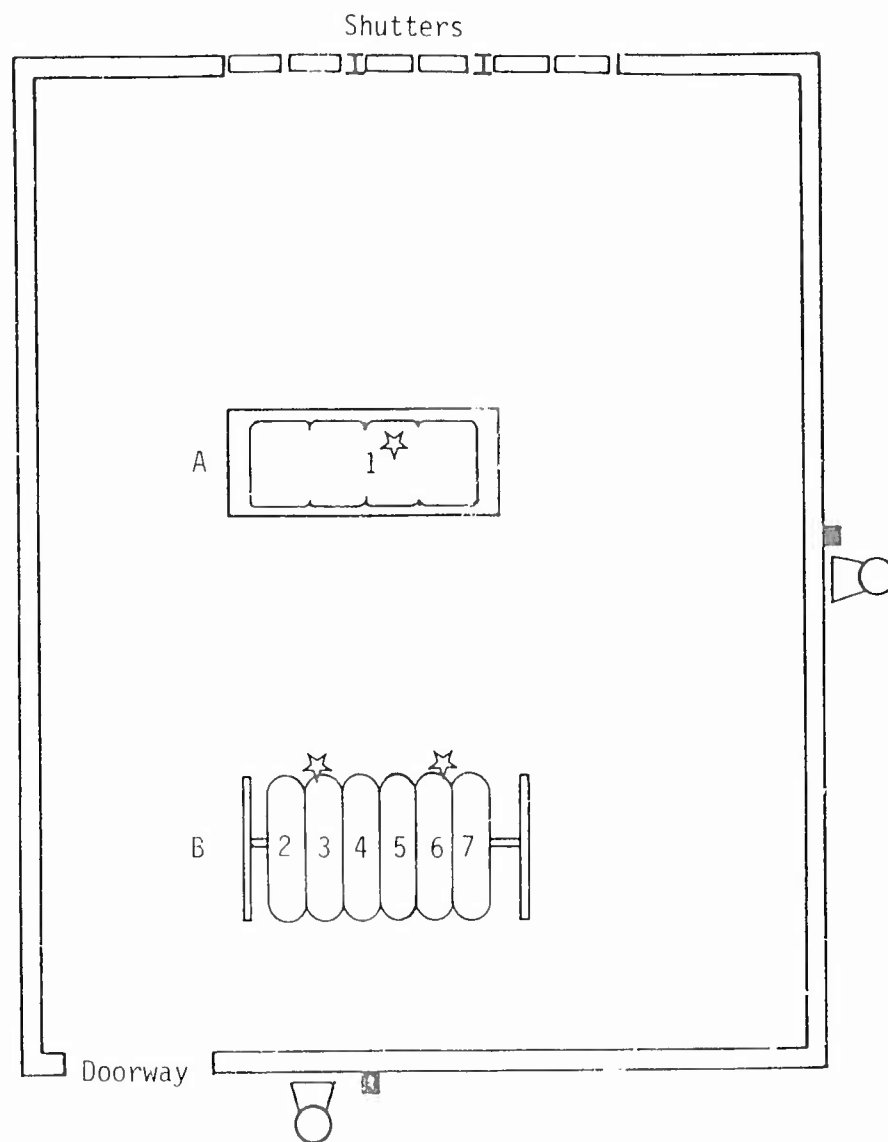
Fig. 6-1. Sketch of Test Geometry, Test Number 6

A simulated clothing store was installed in the center of the test room. A table (made up of two school desks) was placed as shown in Fig. 6-1. On the table were stacked, folded and rumpled piles of denim, drill, terrycloth, and two weights of muslin. Directly behind the table was placed a clothes rack on which coat hangers draped with drill and muslin were placed. See pretest photographs Figs. 6-2A and B, and Fig. 6-3A. Ignition sources were placed on the table and on the coat rack and considerable burning was evident at both locations prior to the blast. The airblast removed all the clothes from the rack and the tables, knocked over the clothes rack and essentially dismantled it (see photograph, Fig. 6-3B). One of the desks (which made up the table) tipped over and ended upside down next to the back wall. The other desk

- A - table made up of two 23 x 18 in. school desks
- B - clothes rack
- 1 - piles of folded drill, denim, terry cloth and muslin
- 2, 3, & 4 - drill
- 5, 6, & 7 - muslin
- ☆ Ignition sources

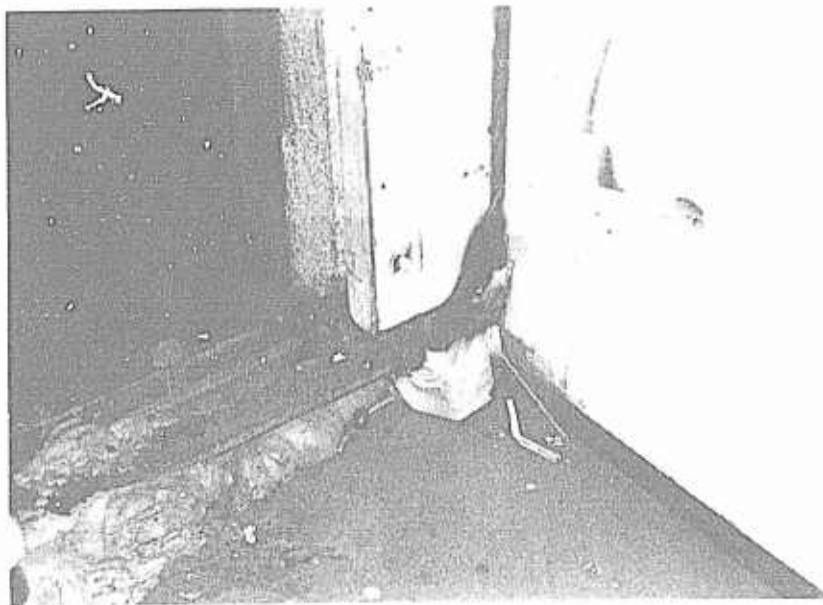
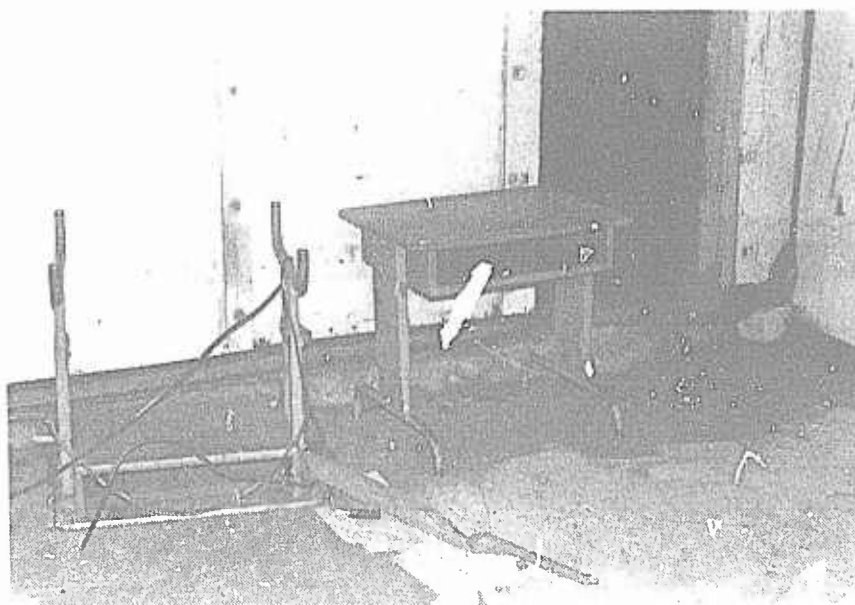
Fig. 6-4. Posttest Photographs, Test Number 6.

rotated 180° and also ended up near the back wall. (See photograph, Fig. 6-4B.) Cloth was scattered a distance of 60 ft outside the doorway. All flames were extinguished, although many pieces were smouldering. One piece (the furthest from the doorway) burst into flame less than 10 minutes after the test. (See Fig. 6-5A and B.) A piece of light weight muslin ignited at 12 minutes and other pieces at later times. Various of these pieces are shown in Figs. 6-6A and B and 6-7. There were also numerous partially burned pieces which were extinguished. (One such piece in the edge of the doorway is shown in Fig. 6-4A.)

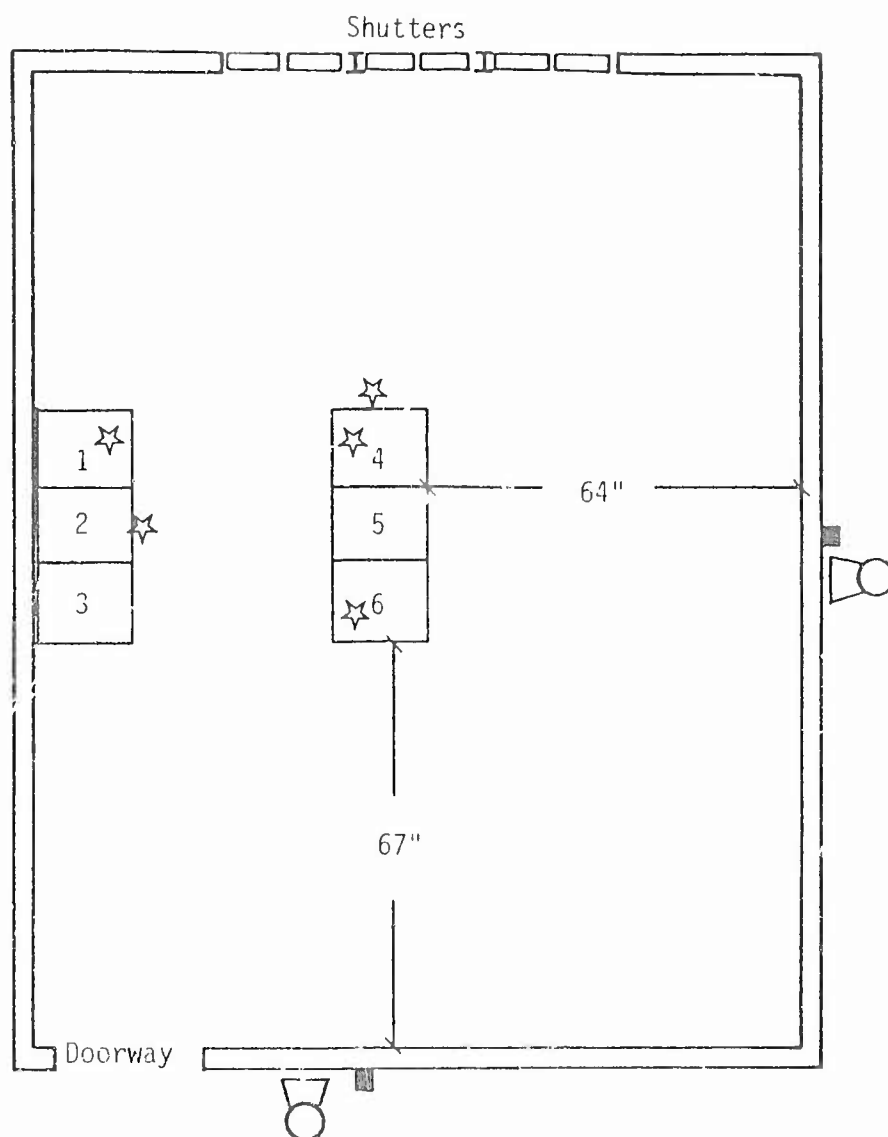
Fig. 7-1. Sketch of Test Geometry, Test Number 7

1, 2, & 3 - 17 x 13 x 13 in. cardboard boxes

4, 5, & 6 - 17 x 13 x 13 in. cardboard boxes stacked three high

☆ Ignition sources

A simulated warehouse was installed in the test room. Nine storage boxes were stacked in the center of the room and three boxes were placed along the wall as shown in the sketch in Fig. 7-1. The boxes contained packing material (crumpled paper). The three boxes along the wall were weighted down (with lead blocks) and the ones in the center were not. Two of the stacks were ignited on the top and front (toward the shutters). See the pretest photographs Fig. 7-2 and Fig. 7-3

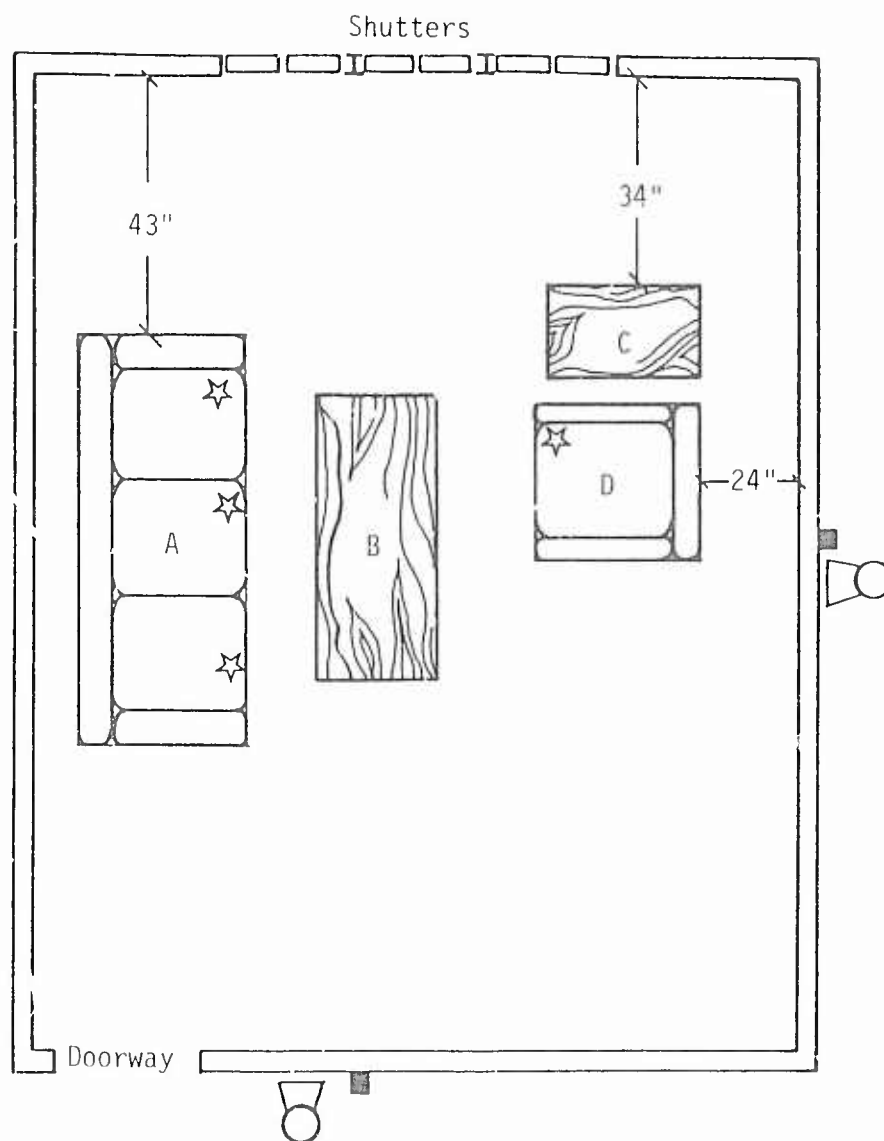
Fig. 8-1. Sketch of Test Geometry, Test Number 8

- A - 69 x 28 in. wood frame sofa with plastic cushions
- B - 48 x 18 in. wood coffee table
- C - 27 x 16 in. wood side table
- D - 30 x 25 in. wood frame arm chair with plastic cushions
- ☆ Ignition sources

The room contained a sofa, coffee table, side table and wood frame chair. In this test the shutters opened prior to ignition, thus no blast-fire data was obtained. Furniture was arranged as shown in Fig. 8-1 through 8-4.

The room arrangement was the same as that for test 8 (see Fig. 8-1). In this case the shutters failed to open and the furniture burned as can be seen in Fig. 9-1. No blast-fire interaction data was obtained.

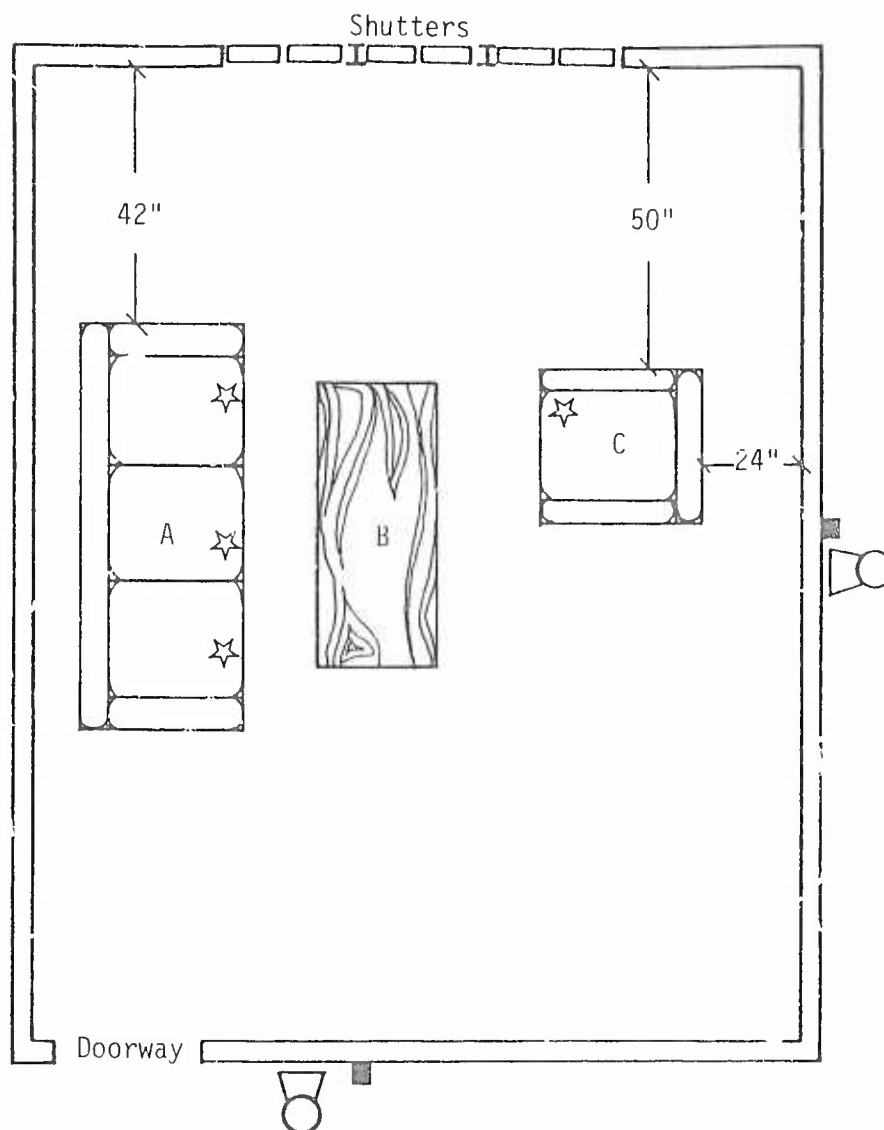
Fig. 10-1. Sketch of Test Geometry, Test Number 10

- A - 69 x 28 in. wood frame sofa with plastic cushions
- B - 48 x 18 in. wood coffee table
- C - 30 x 25 in. wood frame arm chair with plastic cushions
- ☆ Ignition sources

The room contained a wood-frame sofa with plastic cushions, a wood coffee table, and a wood-frame arm chair with plastic cushions arranged as shown in Fig. 10-1. Both ignition and shutter opening took place as planned. All fires were blown out and stayed out. As can be seen in Fig. 10-3, both the chair and table were broken. Most of the cushions were blown outside the test room. On those that were most severely burned, the foam plastic cushioning material was separated from the plastic covers. See Fig. 10-2 and 10-4.

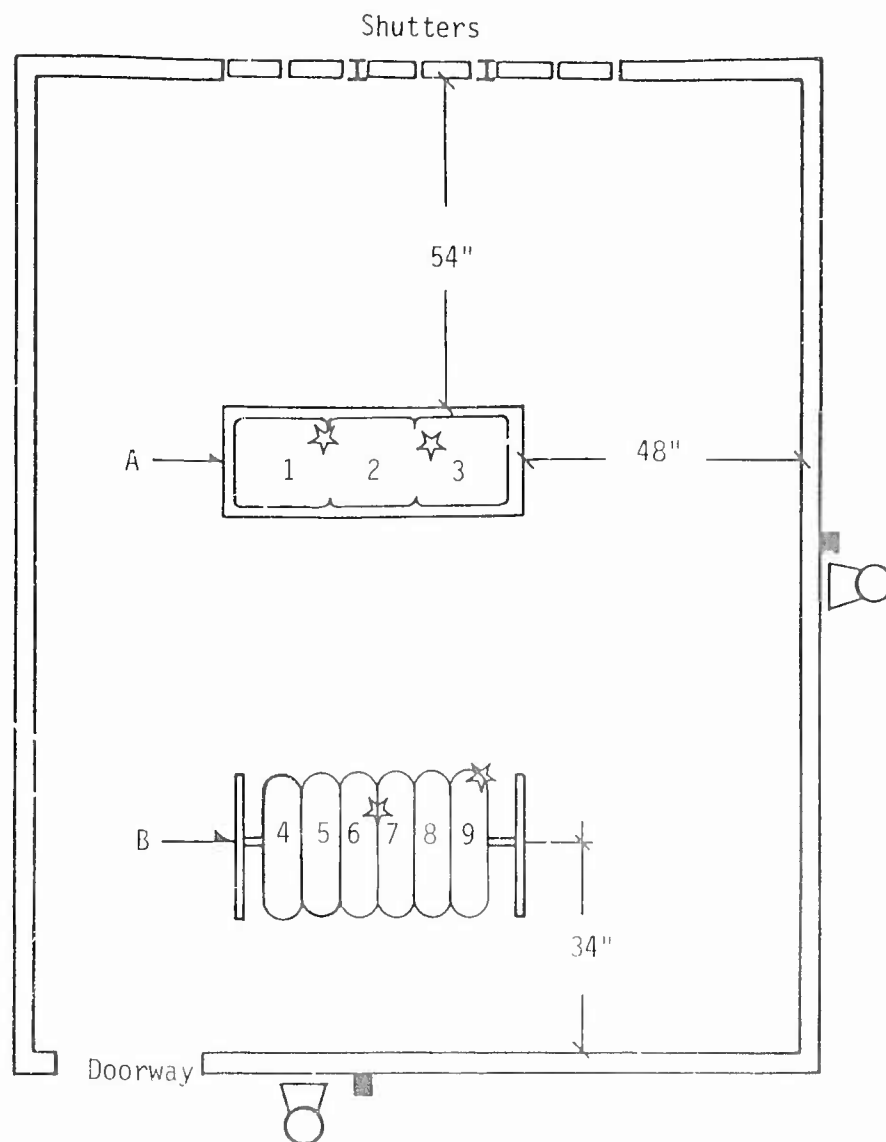
Fig. 11-1. Test Geometry, Test Number 11

- A - 50 x 18 in. table
- B - 49 in. long, 60 in. high clothes rack
- 1 - terry cloth
- 2 - denim
- 3 - mixed duck and muslin
- 4, 7, & 8 - muslin
- 5, 6, & 9 - duck
- ☆ Ignition sources

The simulated clothing store arrangement was similar to that in Test 6, with material arrayed on tables placed upstream from a clothing rack. The table contained terry cloth, denim and 3 ft by 4 ft pieces of duck and muslin, all folded once or twice, arrayed as shown in Fig. 11-1. The clothing rack contained hanging pieces of duck and muslin. The piloted ignition flames can be seen in Figs. 11-2 and 11-3. Damage to the rack and tables was far more severe than in test 6. Most of the cloth was blown out of the room and all fires in this material were extinguished. One piece, however, that was deposited under the central shutter opening smoldered vigorously and burst into flame about 3½ minutes after the shutter opened.

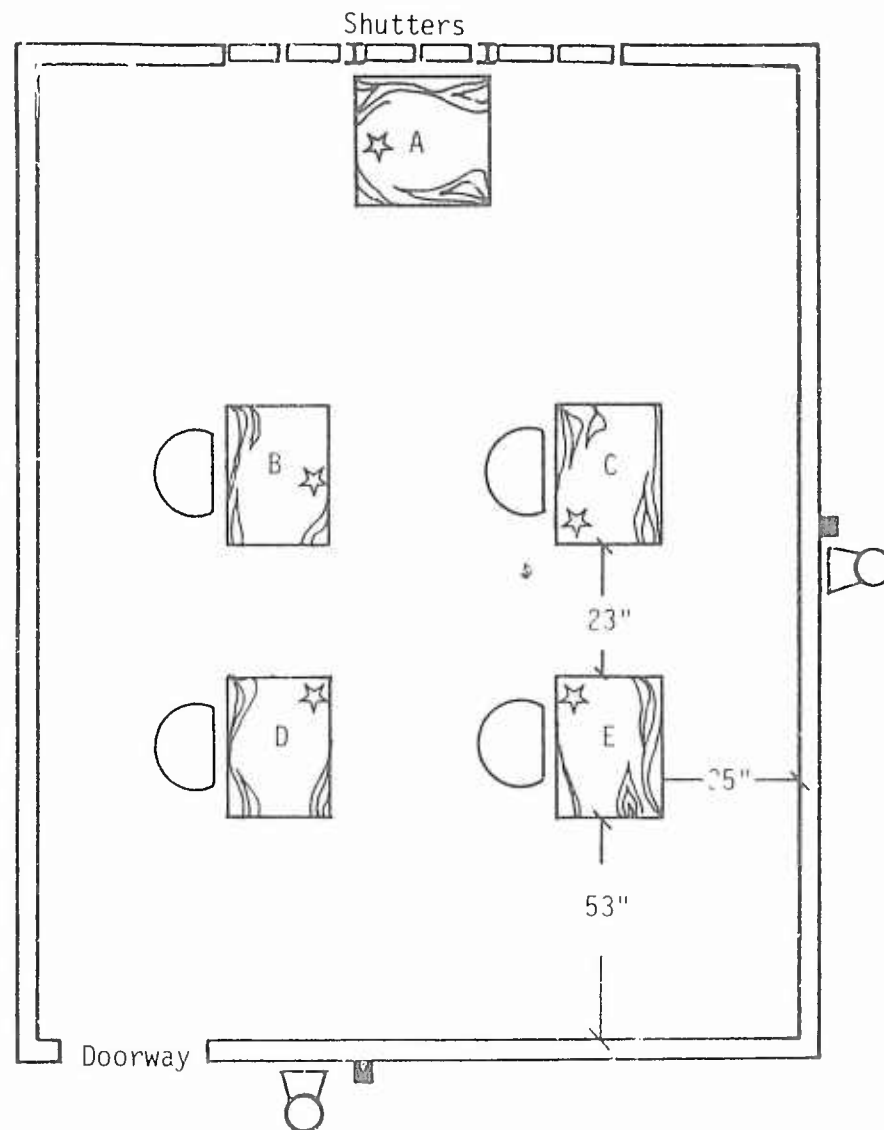
Fig. 12-1. Sketch of Test Geometry, Test Number 12

- A - 24 x 22 in. wood table
 B, C, D, & E - 23 x 18 in. school desk and chair
 ☆ Ignition sources

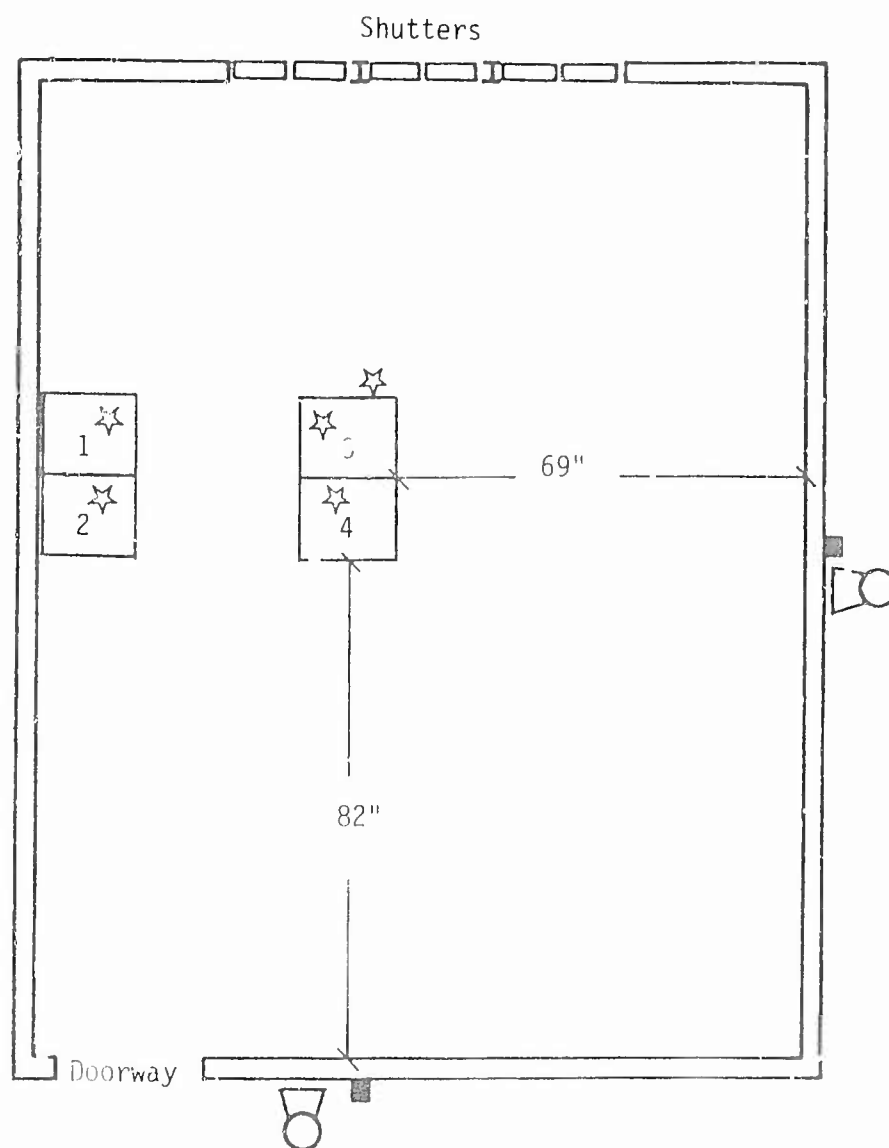
Fig. 13-1. Sketch of Test Geometry, Test Number 13

The overall geometry of this test resembled that of test 7 in that the boxes weighted with lead were arrayed along the side of the room closest to the doorway and the unweighted boxes containing paper were placed near the center of the room. In this test, however, there were two empty weighted boxes along the side wall, where in test 7 there were three boxes containing crumpled paper. Furthermore the central stacks consisted of six boxes (two rows, three boxes high) in this test, as shown in Fig. 13-2, in place of the nine box stack (three rows, three boxes high) of test 7. Additionally, only the front row of boxes (toward the shutters contained paper).

- 1 & 2 - 17 x 13 x 13 in. cardboard boxes
- 3 & 4 - 17 x 13 x 13 in. cardboard boxes (stacked three high)
- ☆ Ignition sources

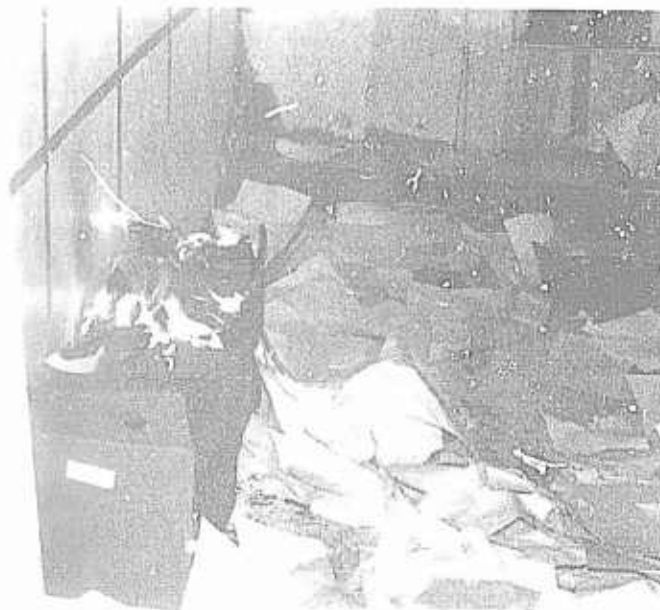
Fig. 13. Pre and Posttest Photographs, Test Number 13

After the test, the side (weighted) boxes were flaming, and about one half the paper content of the central stack was distributed over the entire floor of the test room (See Fig. 13-3 and 13-4). The remainder of the paper was blown out the rear doorway and did not re-ignite.

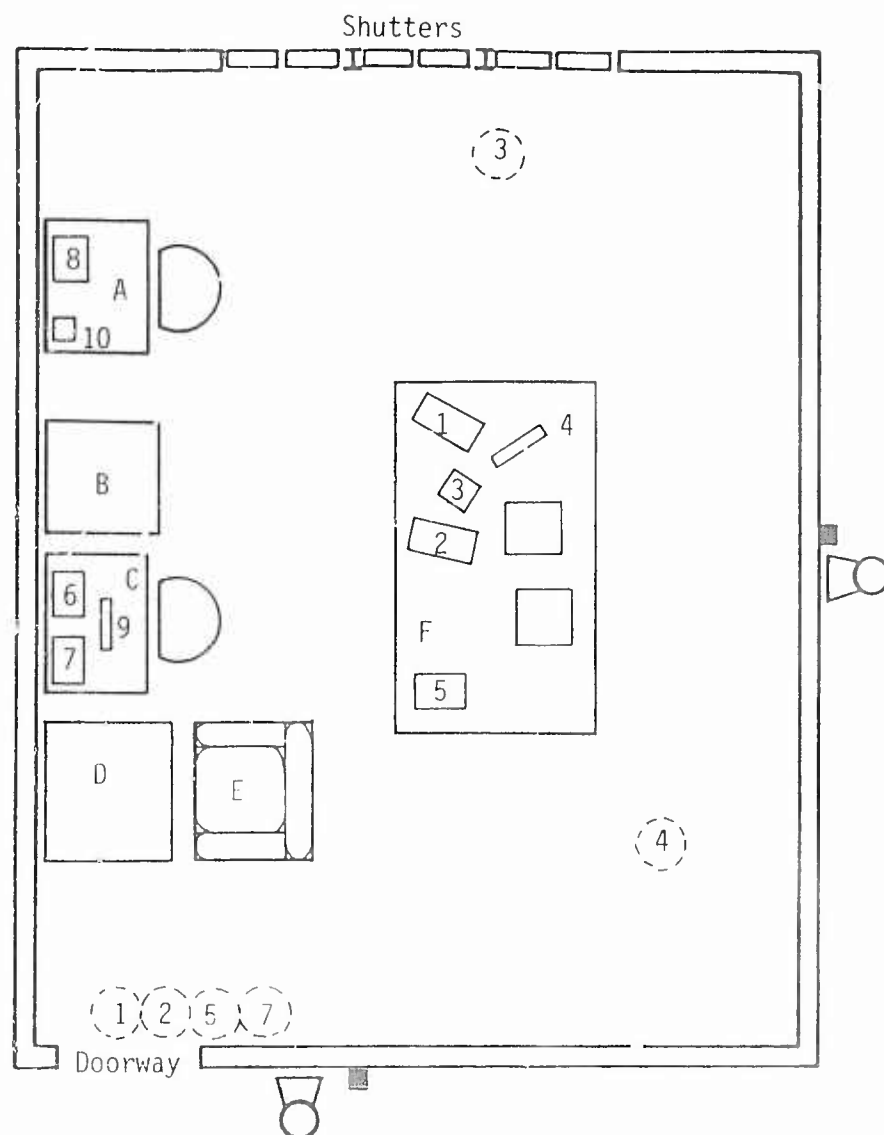
Fig. 14-1. Sketch of Test Geometry, Test Number 14

The simulated EOC test geometry is sketched in Fig. 14-1. The equipment tested included a large radio rack, teletype, desks, chair and numerous items of radiation equipment. These items were as follows:

<u>Item Number</u>	<u>Item</u>
1	CDV-717 Model 1-1 (94500)
2	CDV-715 Model 1-A (95049)
3	Charger (55918)
4	Dosimeter (0852045)
5	CDV-700 Model 6A (56659)
6	CDV-1A (37641)
7	CDV-6A (28804)
8	CDV (16010)
9	Dosimeter (0829919)
10	Charger (02429)

- A & C - 23 x 18 in. school desks
- B - 20 x 20 x 84 in. relay rack
- D - 20 x 24 x 27 in. teletype
- E - steel frame chair with plastic cushions
- F - 34 x 60 in. wood desk

Note: For descriptions of equipment 1 through 8 see text. Numbers in dotted circles indicate posttest locations.

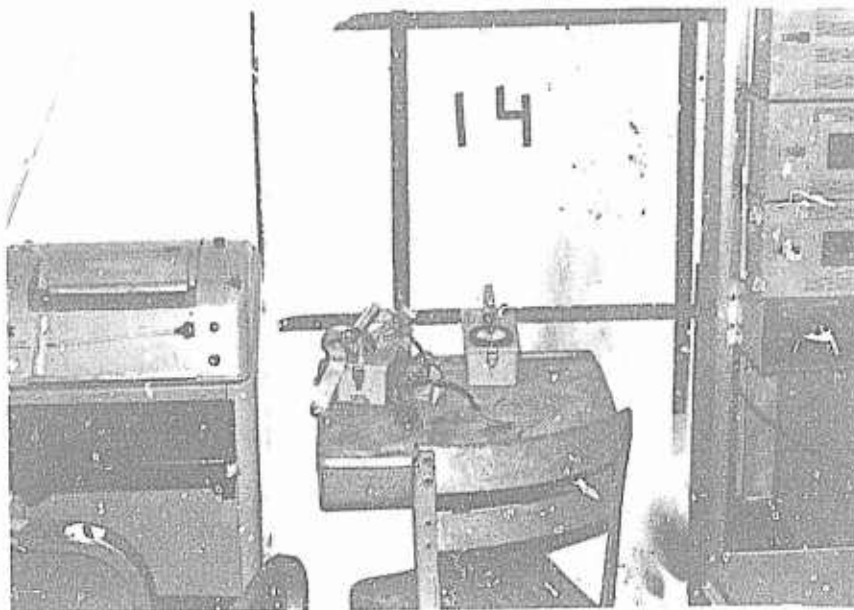
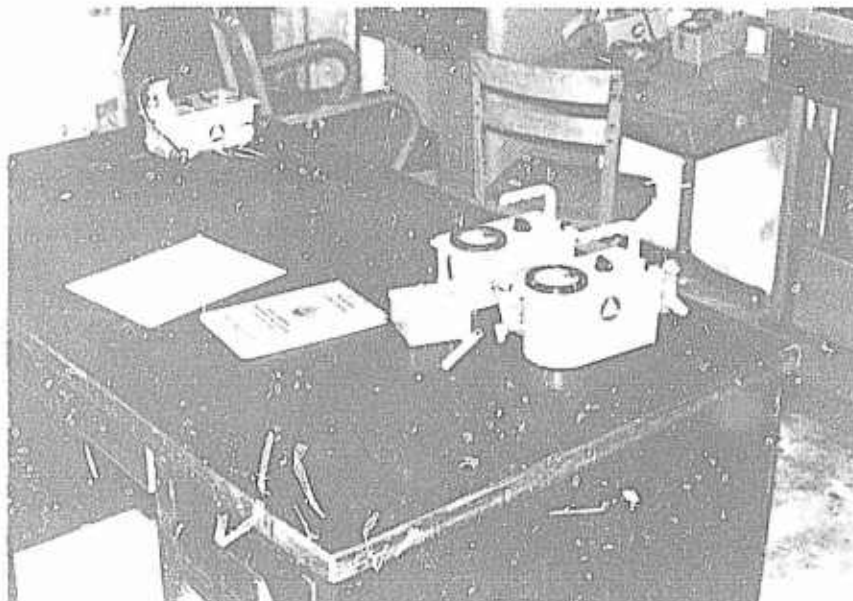
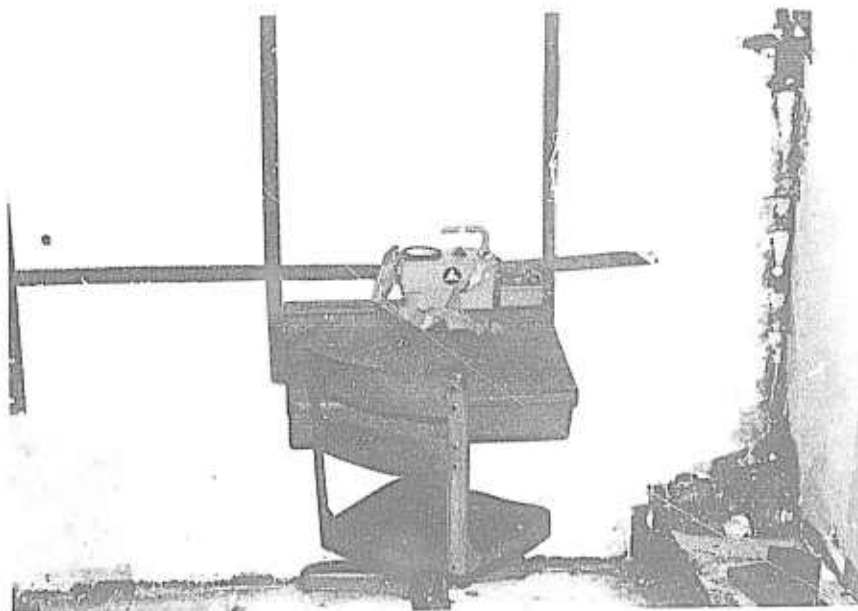
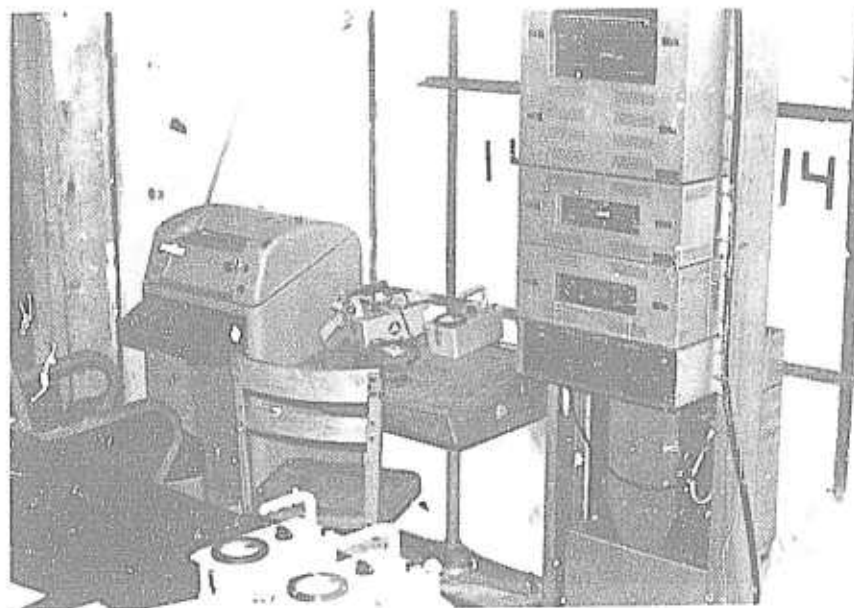
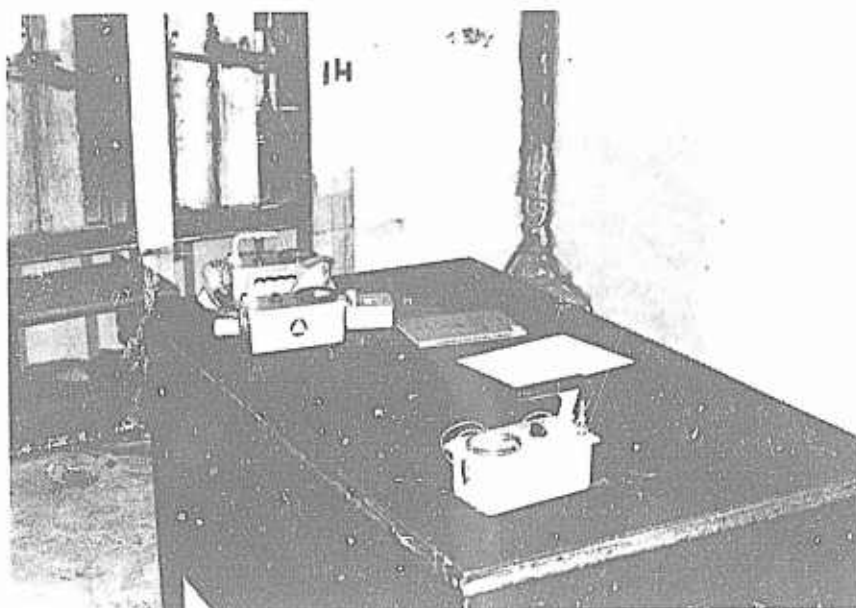
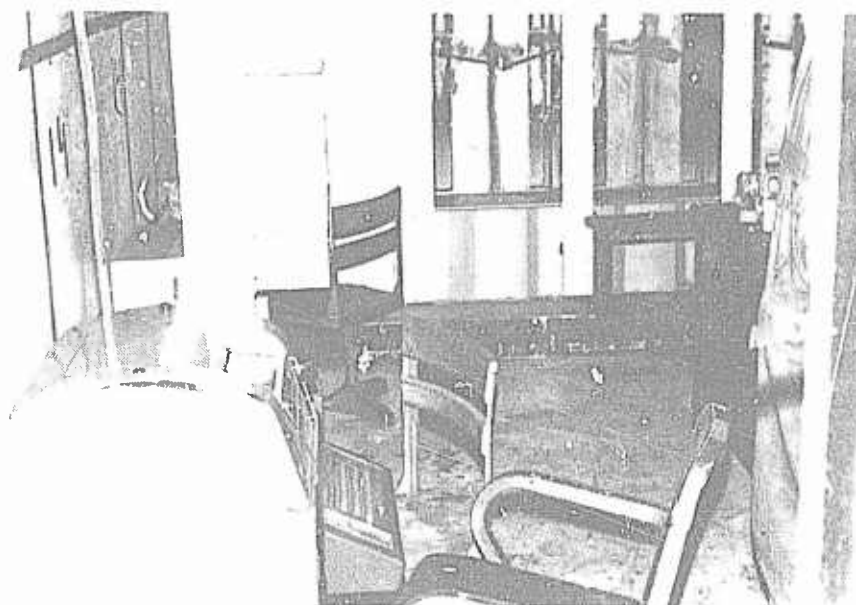
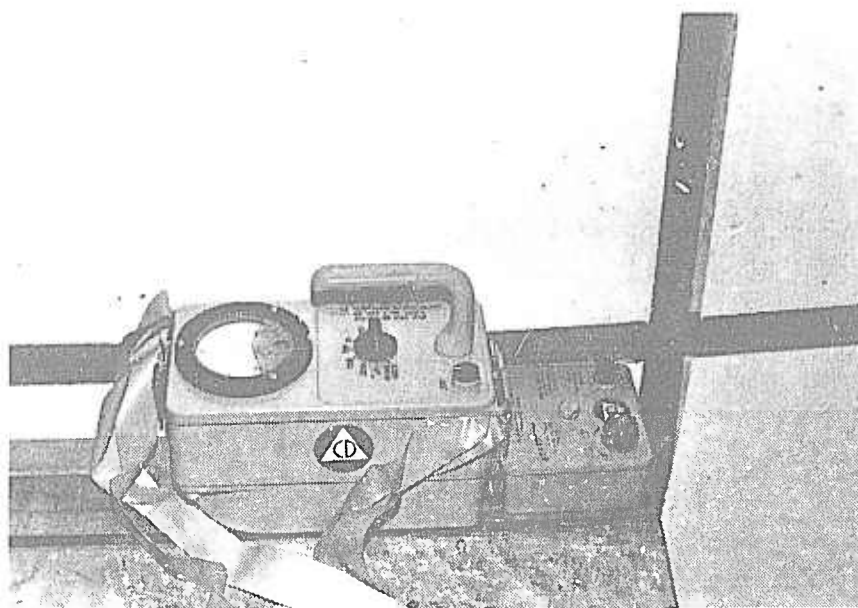
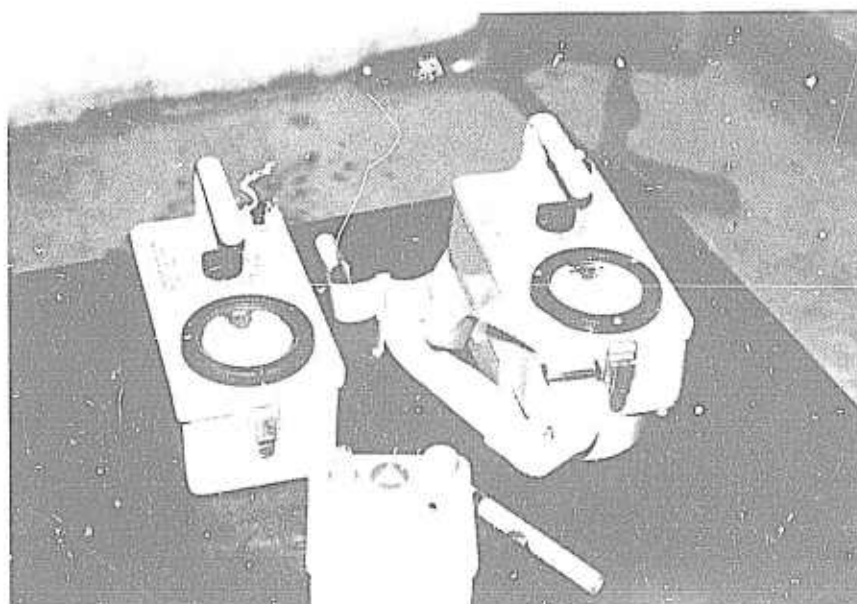
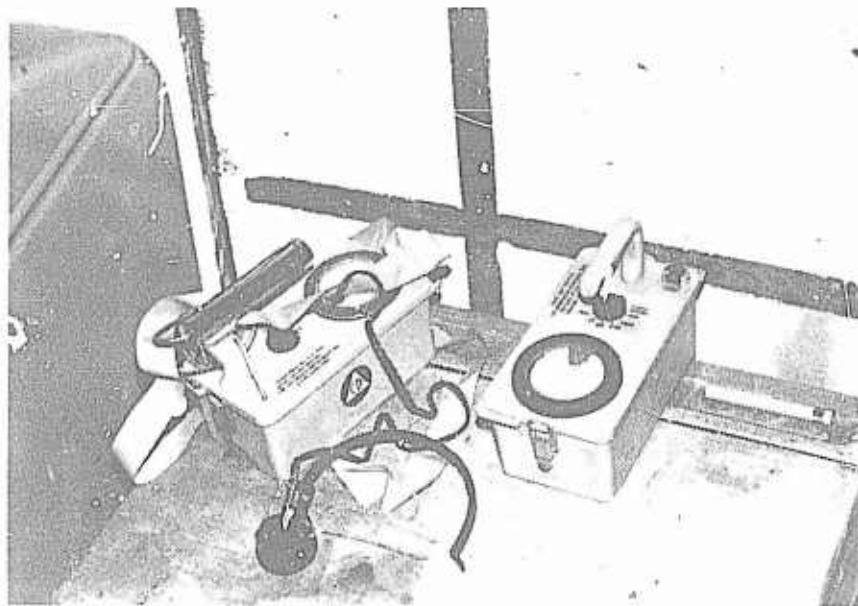
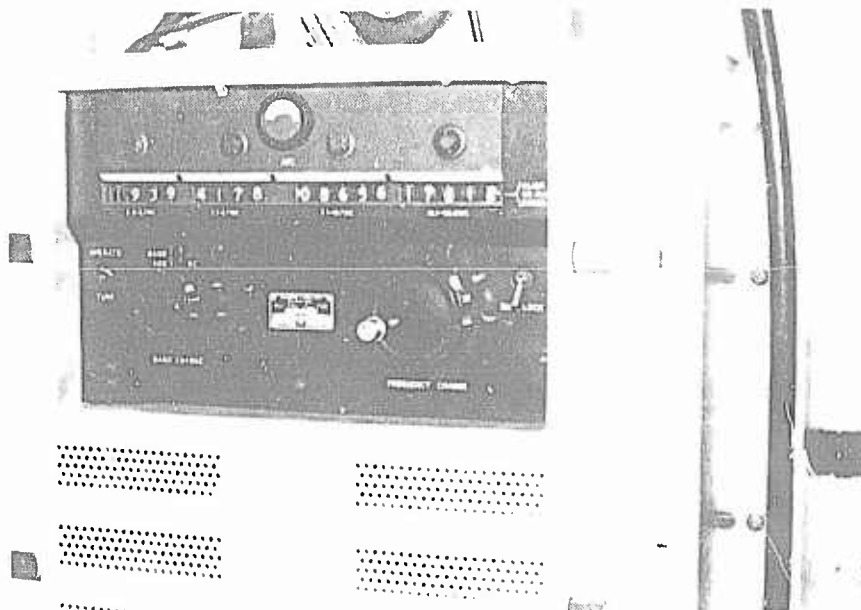
The pretest arrangement (including the above items of equipment) is shown in Figs. 14-2 through 14-6. The blast severely damaged the desk, originally located in the center of the room. The top was broken in half and was found in front of the doorway. Most of the remainder of the desk was found outside the door in the hallway. The teletype and chair were heavily damaged and were found in the outside corridor. The chair was 17 ft from the doorway and the teletype 38 ft. Items 1, 2, 5, and 7 were found in front of the doorway under the debris from the desk. All were damaged and only two of them showed any response when turned on. Item 4 (dosimeter) was badly damaged and was found near the back wall. All other items were undamaged. Posttest photographs from this test are presented in Figs. 14-7 through 14-14.
